<p align="center">Project Completion Report (First Phase) CLC Power Co. Ltd, Washpur, Dhaka, Bangladesh</p>

CLC Power Co. Ltd, a 108MW Diesel Fuel Power plant located at Washpur, Keranigonj, Dhaka, Bangladesh.

Project : Zinganisation of 12 Fuel Oil, Lub Oil and Water Tanks and associated pipes.

Scheme : Under coat 60-80 micron Zinga. Top coat 50-60 micron PU coating.

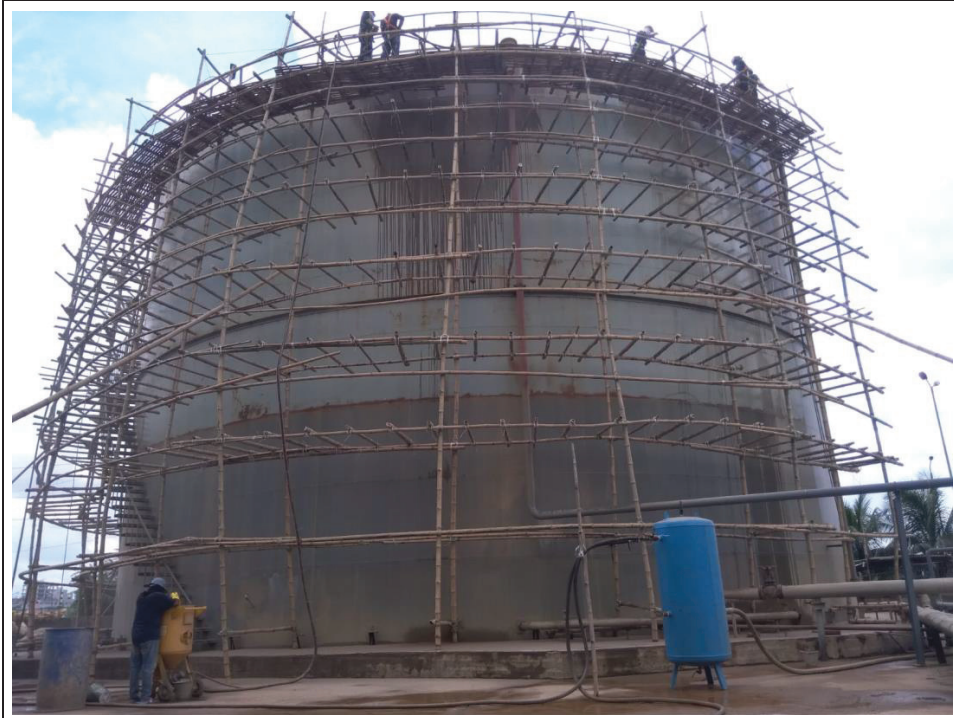
1. Erected bamboo scaffolding and blasting tank HFO Tank No. 1

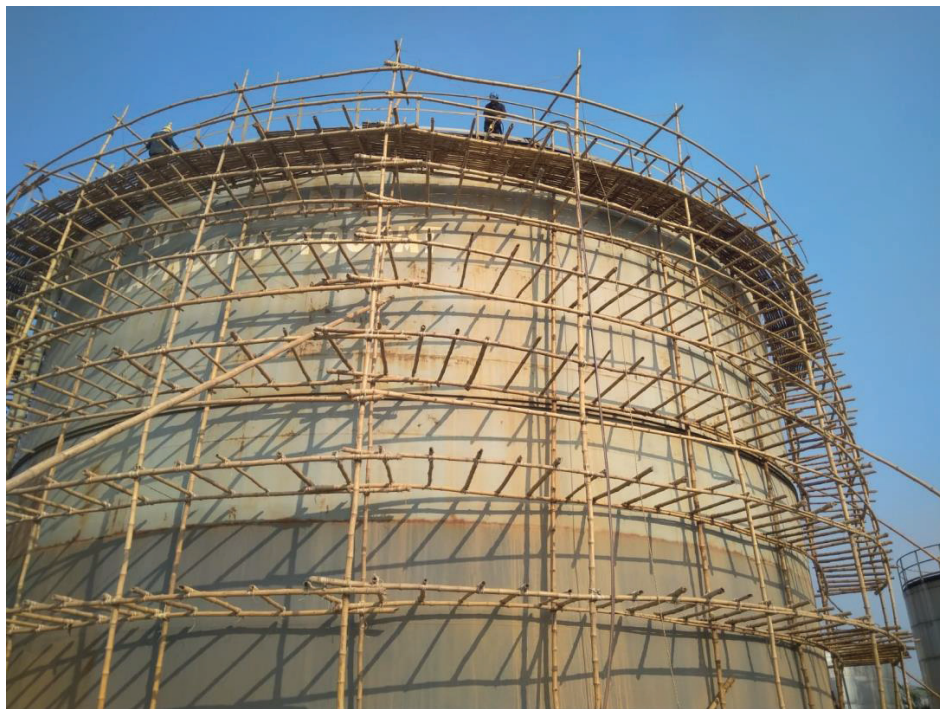
2. Erected bamboo scaffolding and blasting tank HFO Tank No. 2

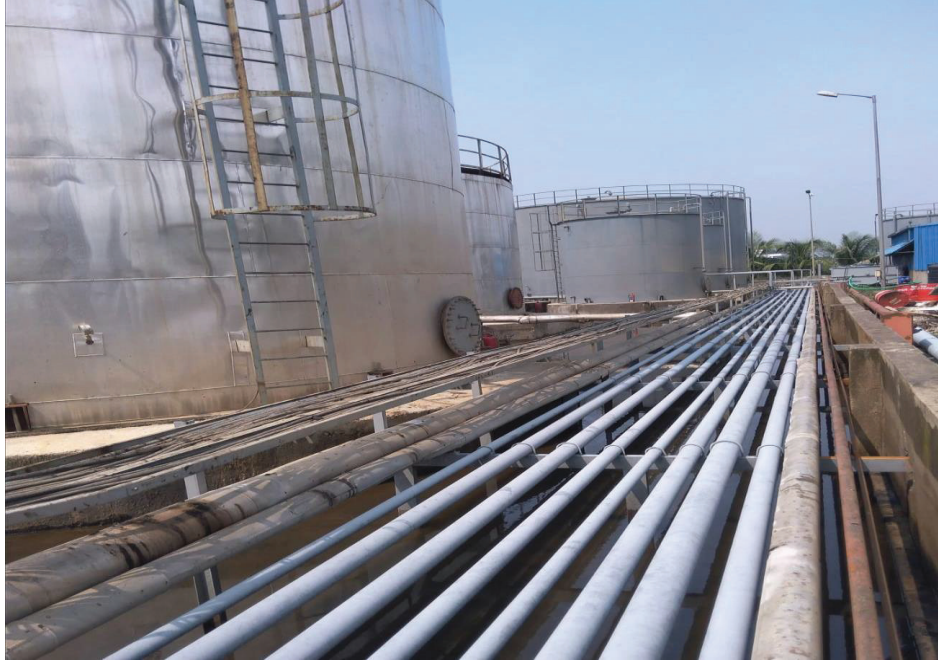
3. Blasted and applied Zinga on the associated pipes

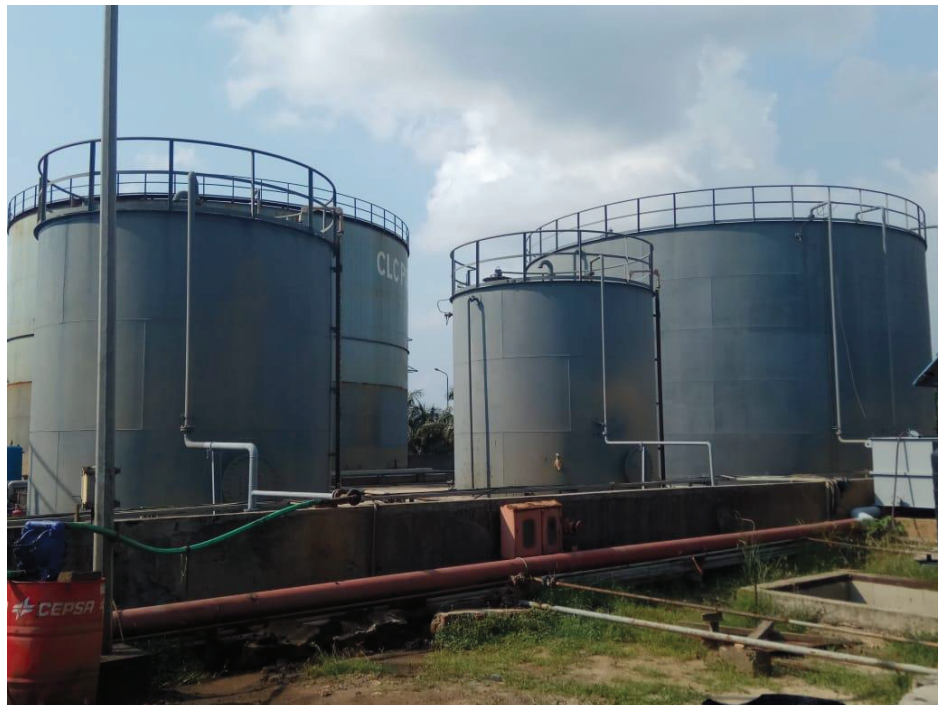
4. First coat Zinga application (30 micron) in progress.

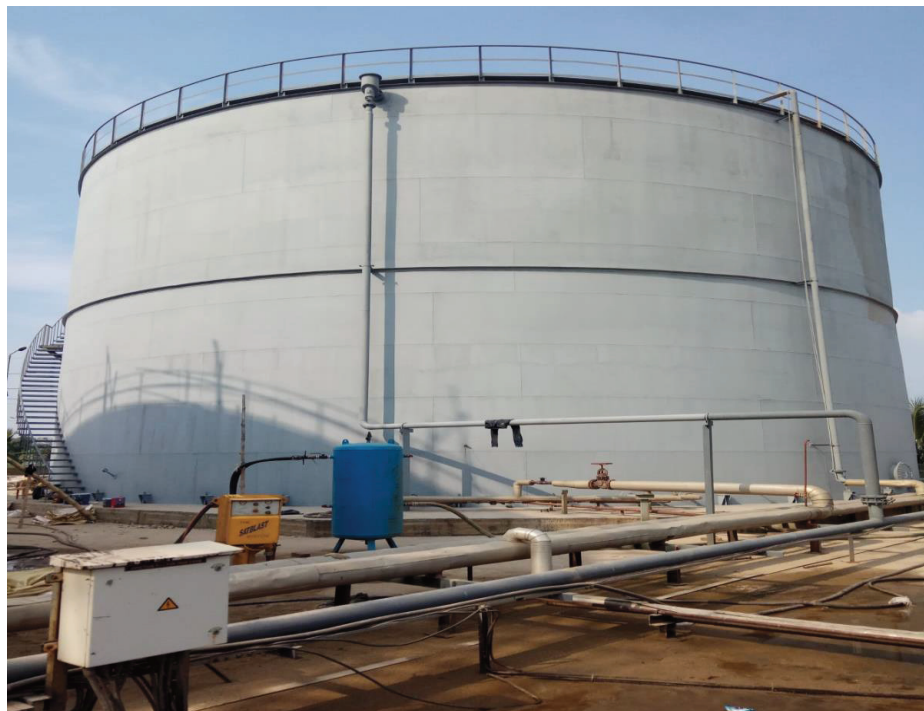
5. Zinga application 70-80 micron completed.

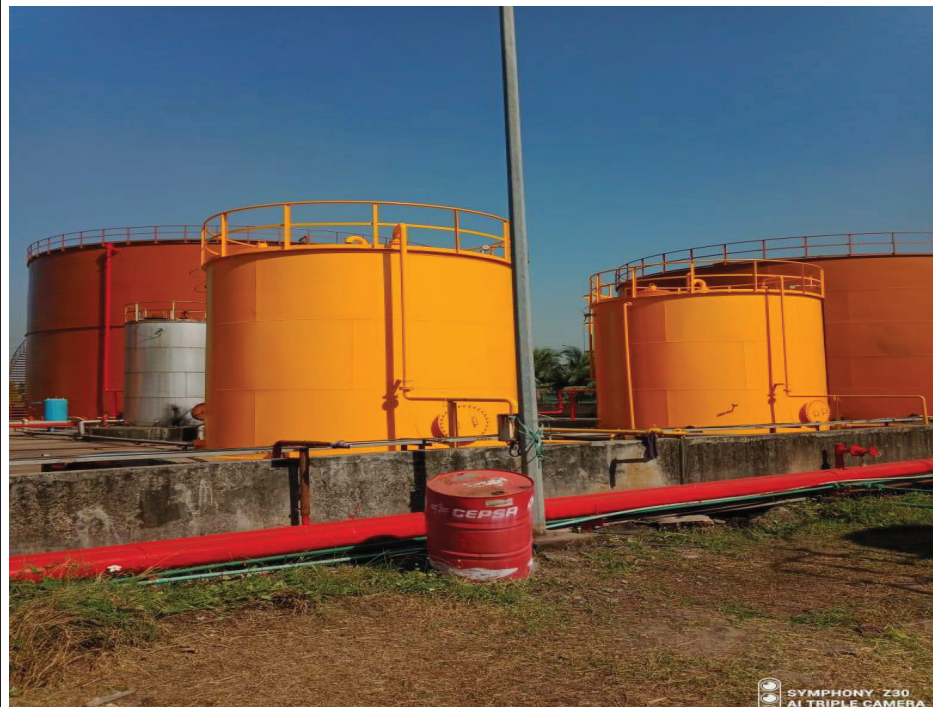
6. Top PU coating 50-60 micron completed.

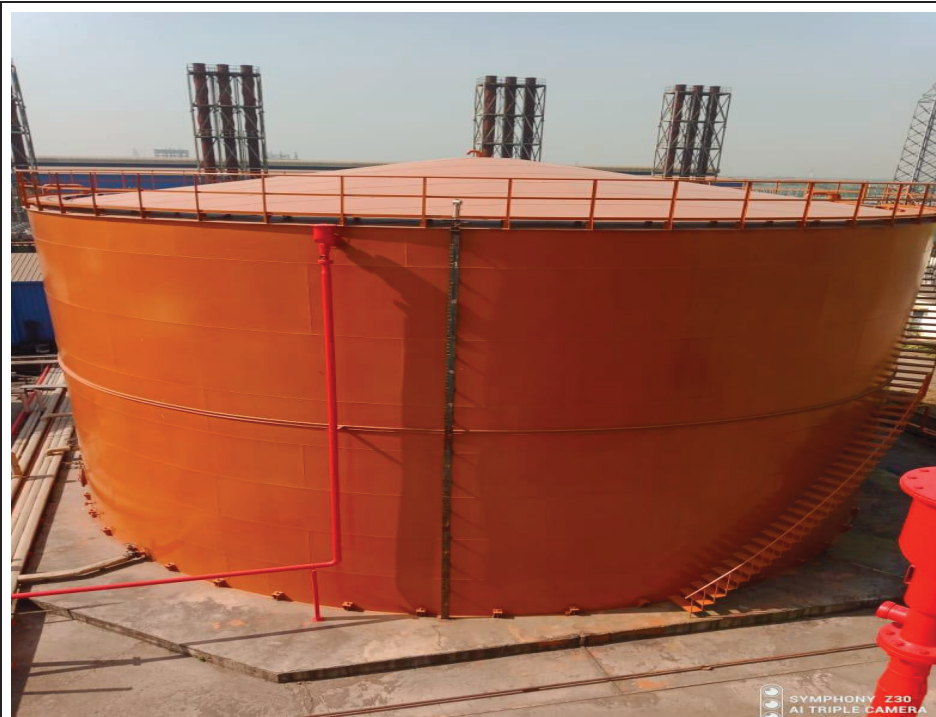
7. Top PU coating 50-60 micron completed.

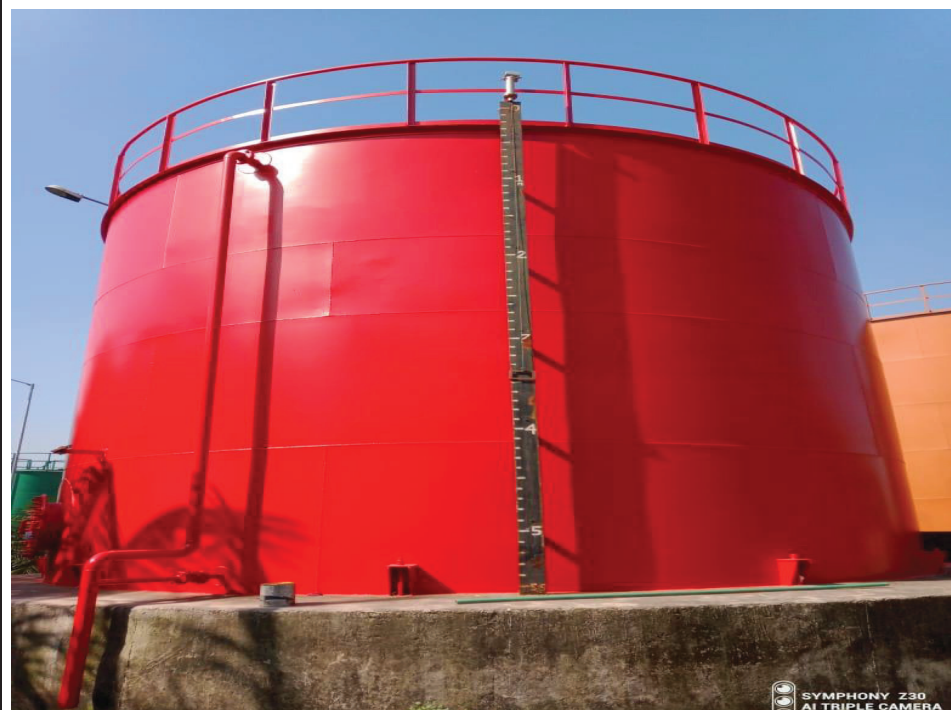
8. Top PU coating 50-60 micron completed.

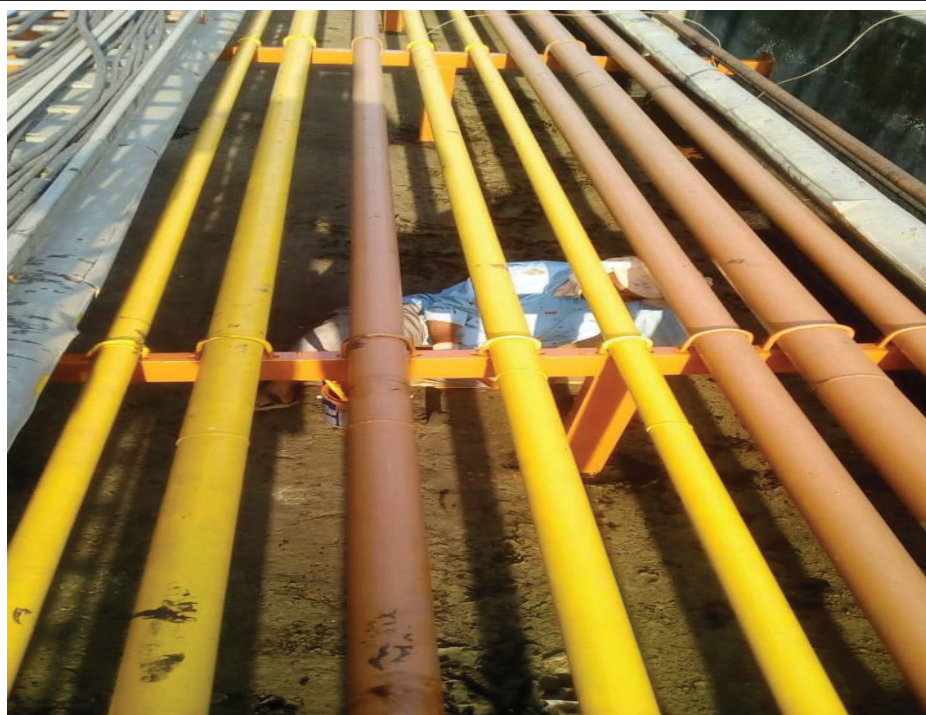
9. Top PU coating 50-60 micron completed.

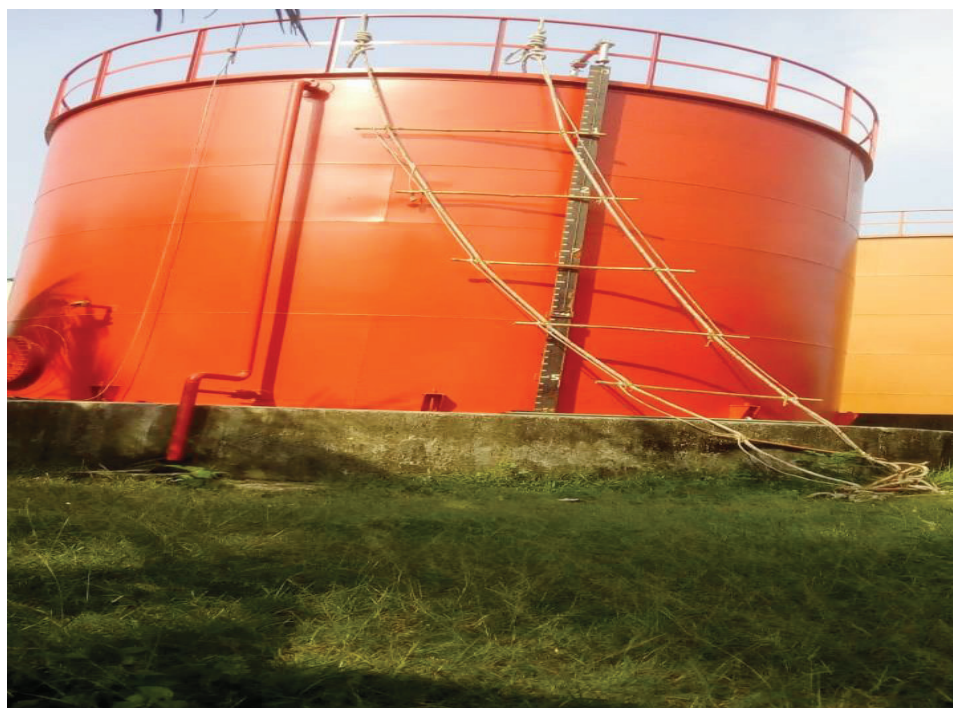
10. Top PU coating 50-60 micron completed.

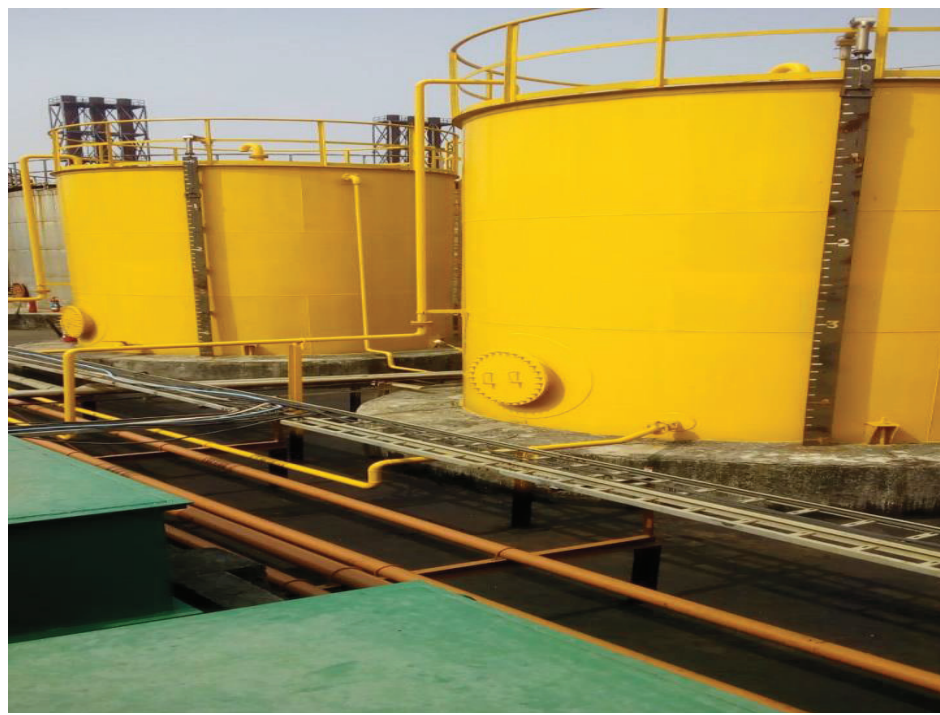
11. Top PU coating 50-60 micron completed.

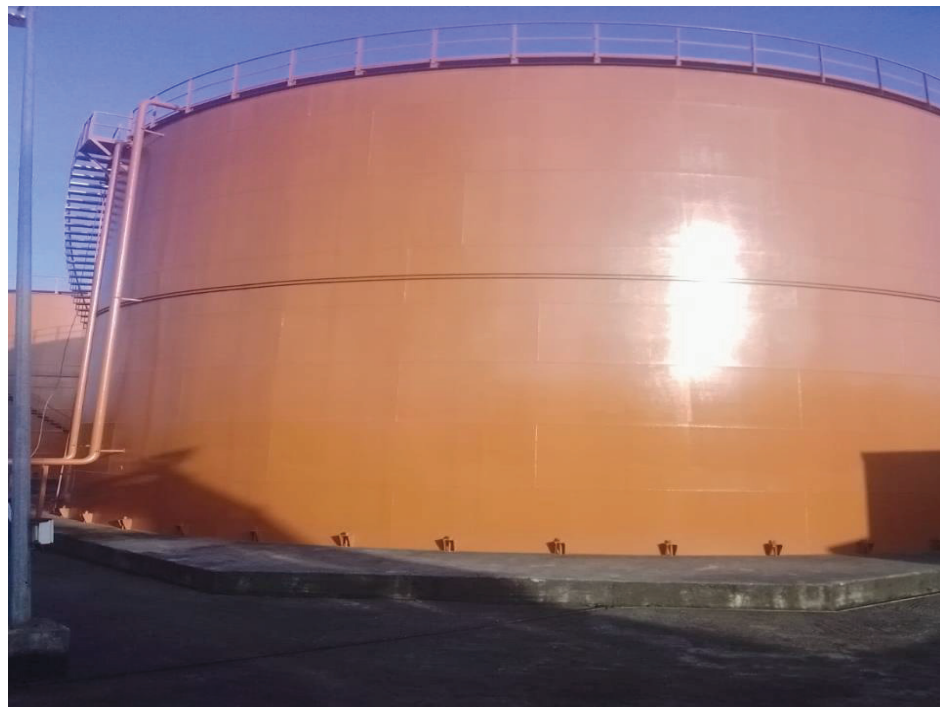
12. Top PU coating 50-60 micron completed.

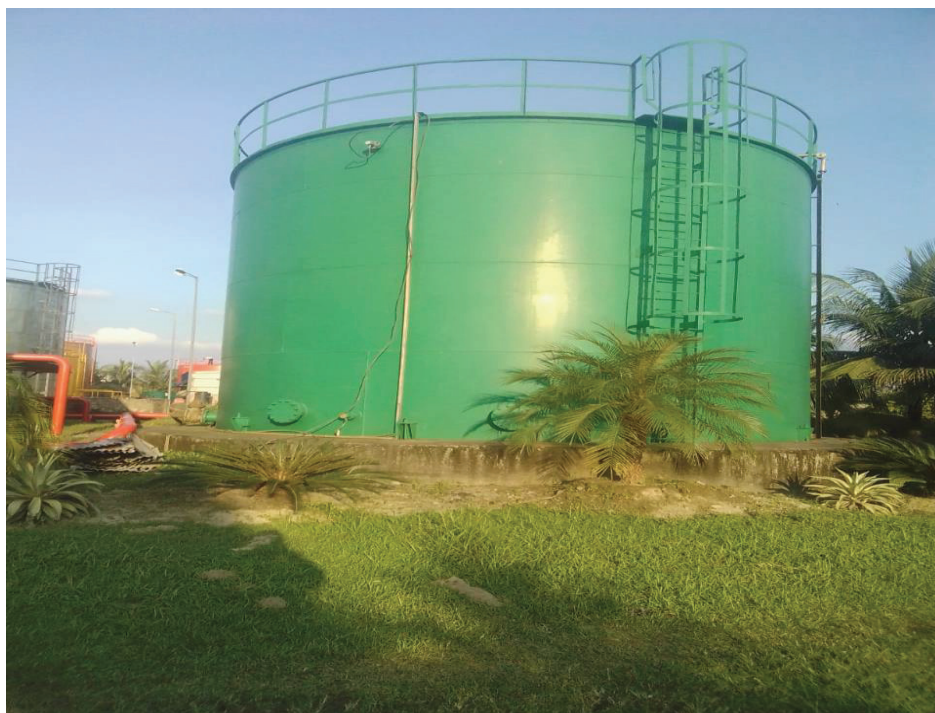
13. Top PU coating 50-60 micron completed.

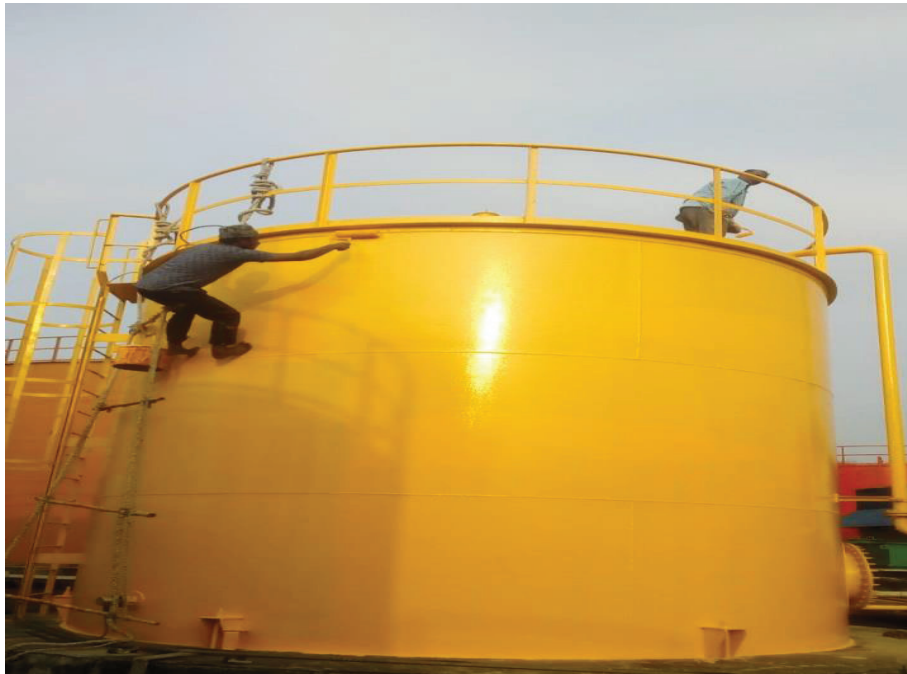
14. Top PU coating 50-60 micron completed.

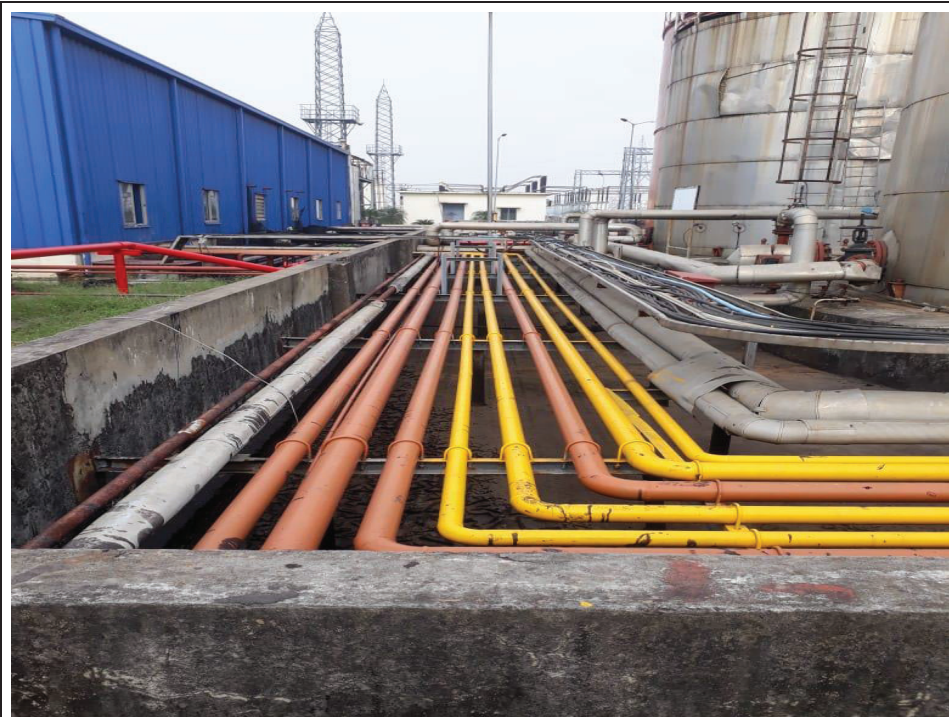
15. Top PU coating 50-60 micron completed.

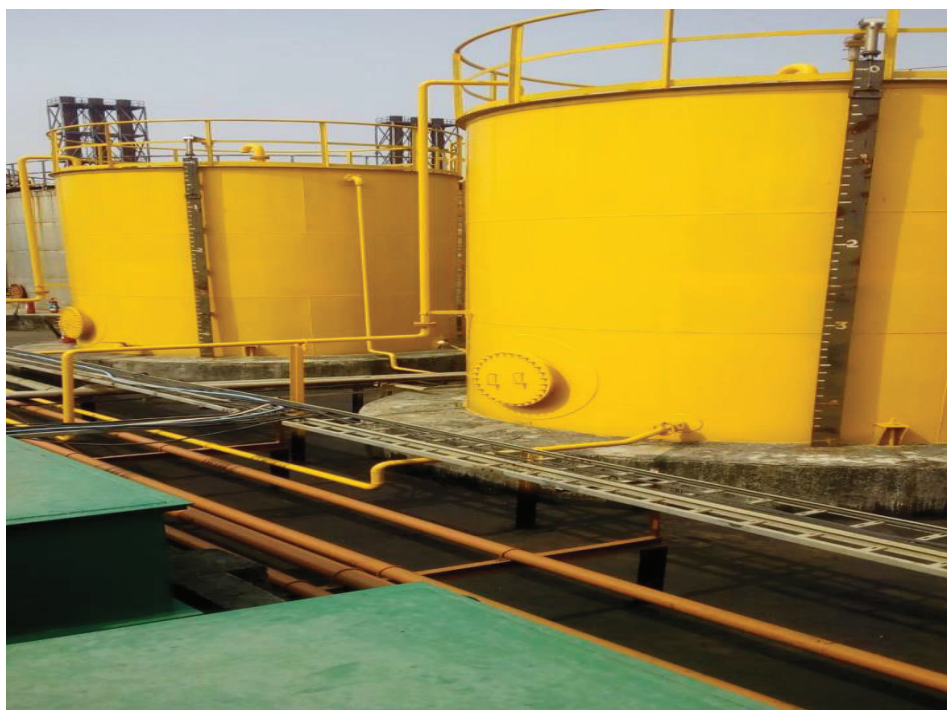
16. Top PU coating 50-60 micron completed.
